Navajo Abandoned Uranium Mine Site Screen Report

Section 16 Deposit AUM Site

Navajo AUM Eastern Region

May 2009

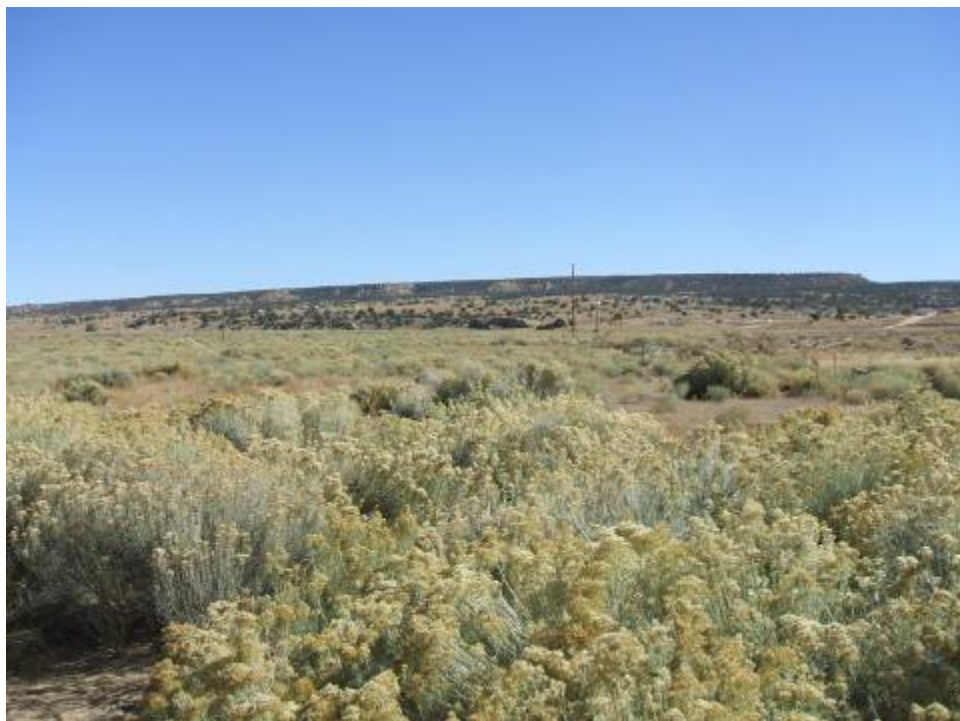
Photo 1. Section 16 Deposit site, towards the east

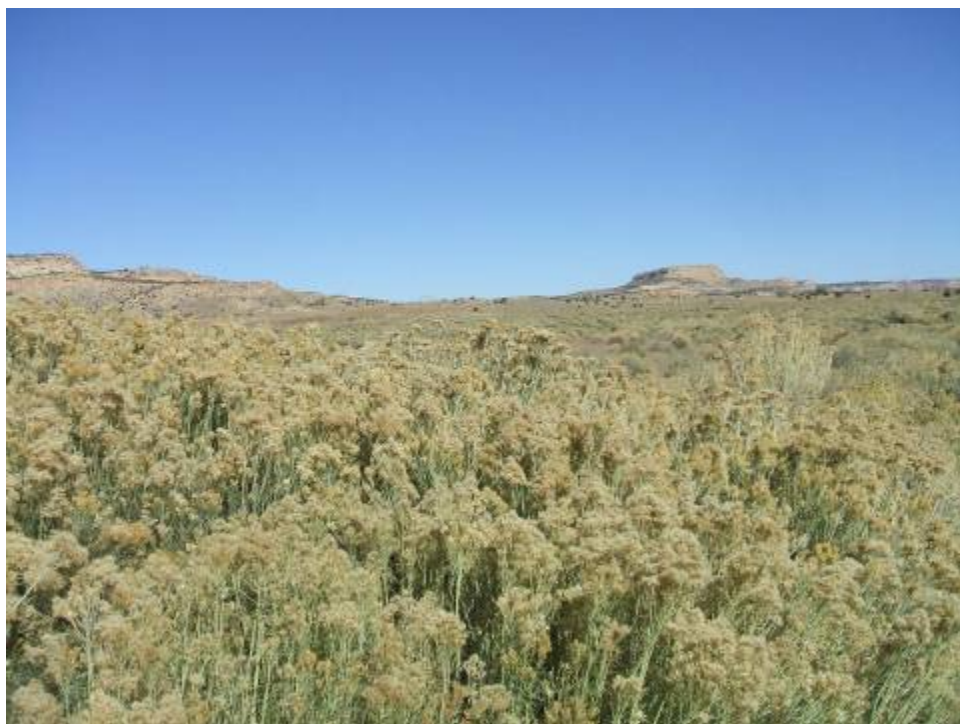
Photo 2. Section 16 Deposit site, towards the north

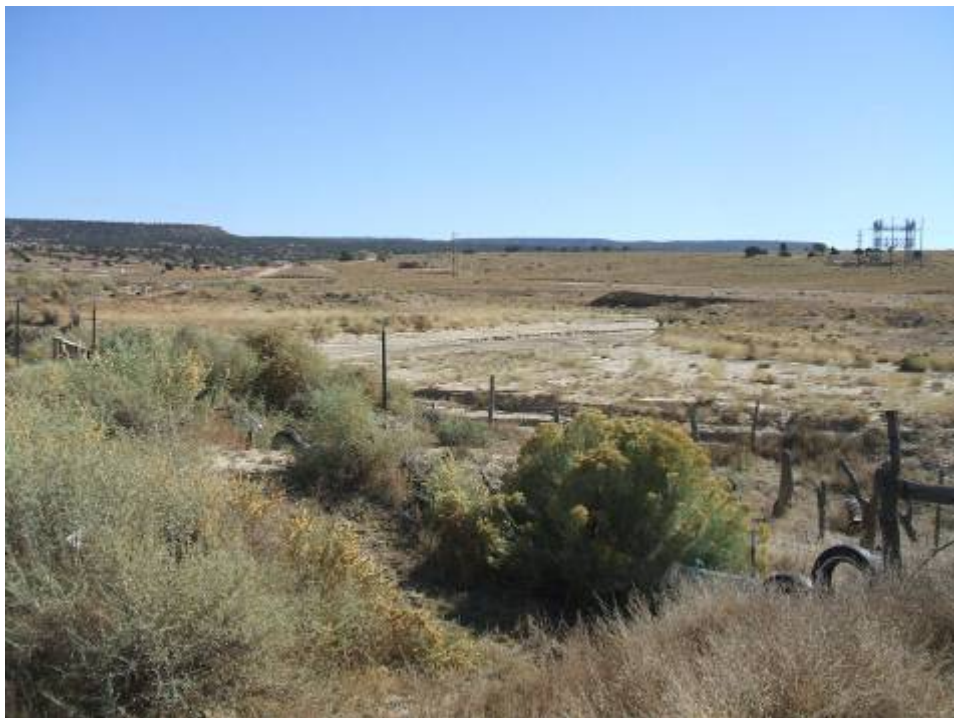
Section 16 Deposit mine consists of an area of 911,757.33 square meters. Any historical information pertaining to mining operations and historical ownership of the mine site appeared to be unclear. Two riverbeds/washes were found along the eastern and southern edges of the site (Photo 3, 5).

Photo 3. River bed / wash area along the southern edge of the site, towards the southeast

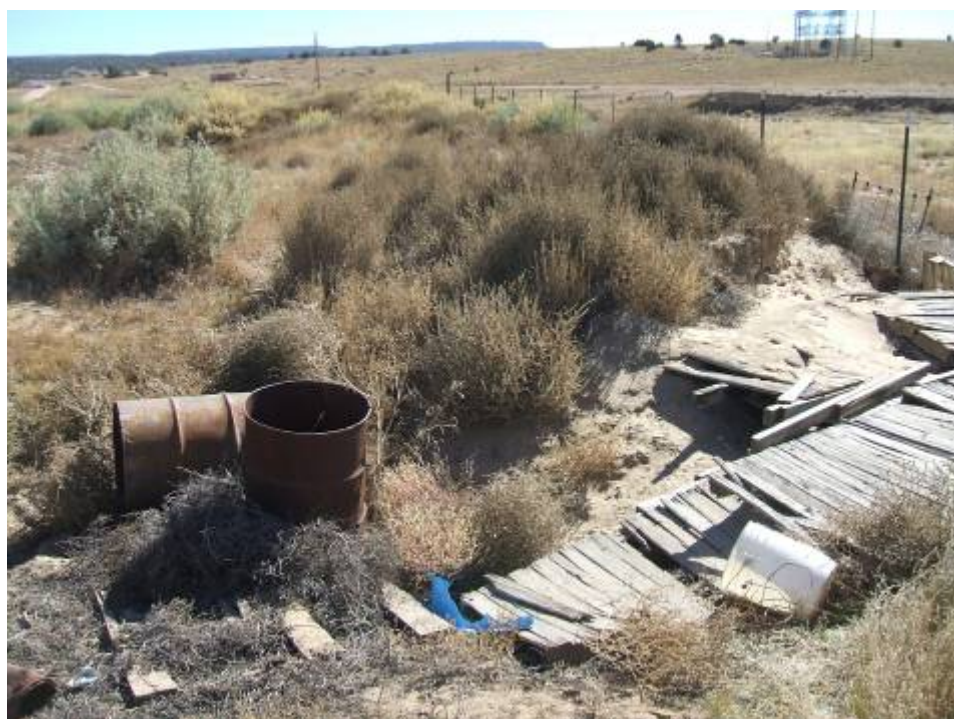
0 to 200 feet: 1 home located along the northwestern edge of the site (Photo 6). Gamma radiation levels near the house were found less than 2 times background levels. Home also includes a small livestock stable and 2 small wood structures. Field personnel was unable to contact the occupants. Several other wooden structures were found throughout the site (Photo 9, 10). Empty drums and other waste was found along the southern portion of the site (Photo 4).

Photo 4. Empty drums and wooden boards found along the southern edge of the site, towards the south

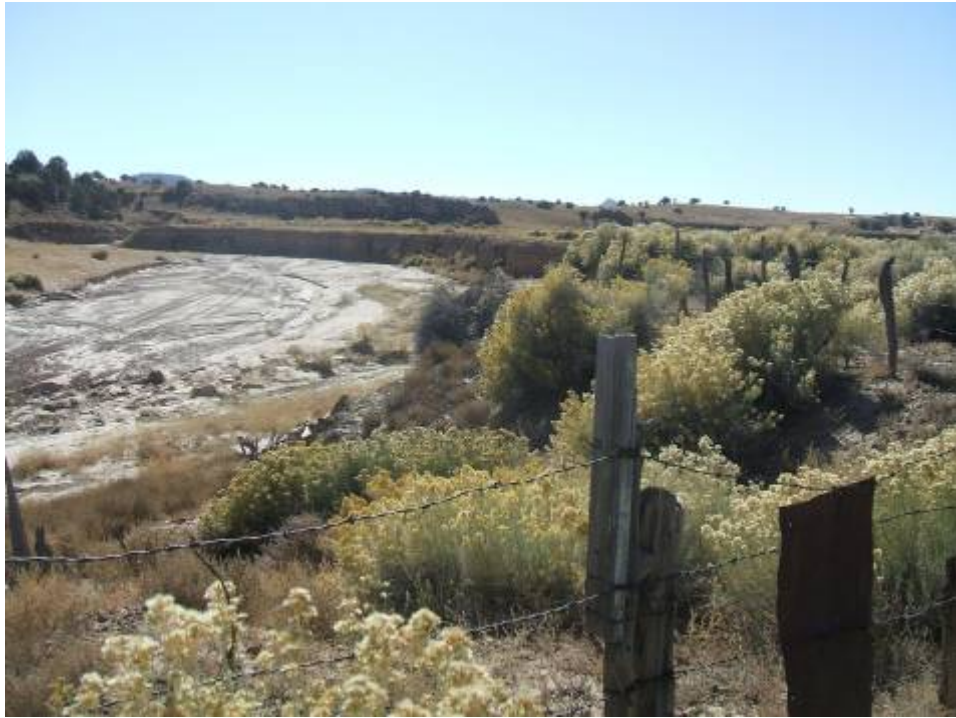
Photo 5. River bed / wash area along the eastern edge of the site, towards the southeast

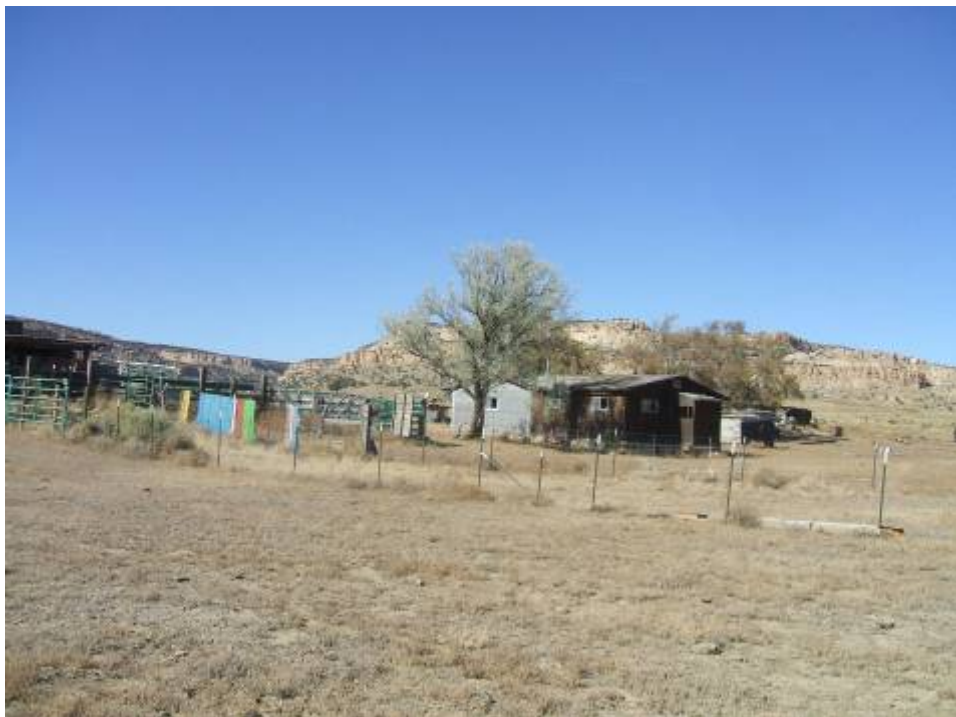
Photo 6. Housing complex located along the western edge of the property, towards the west

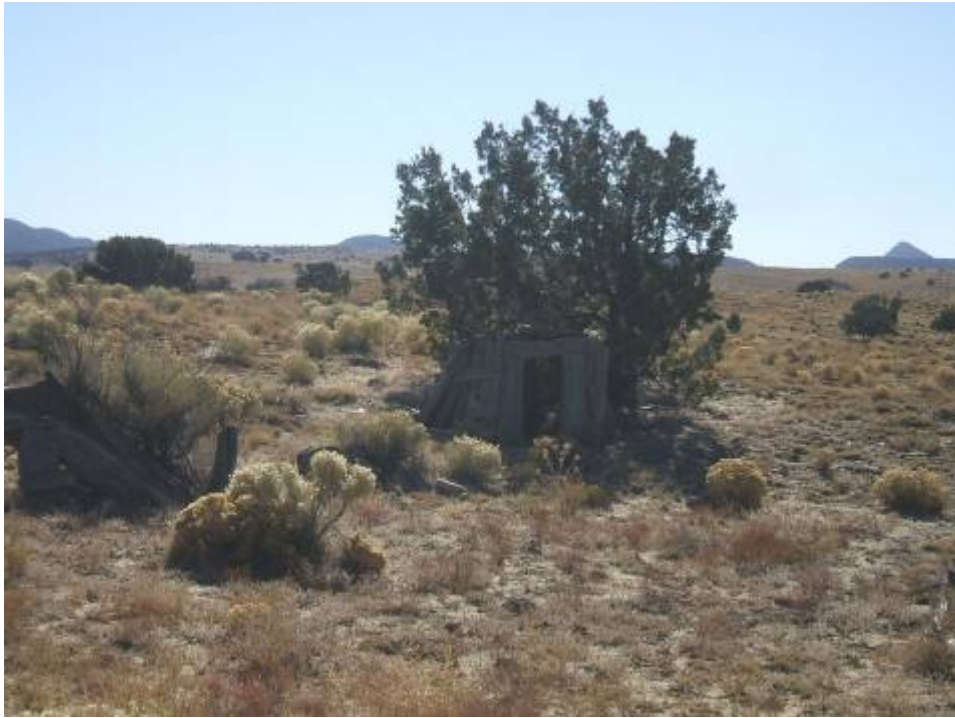
Photo 7. Small wooden structure found within the central western area of the mine site, towards the east

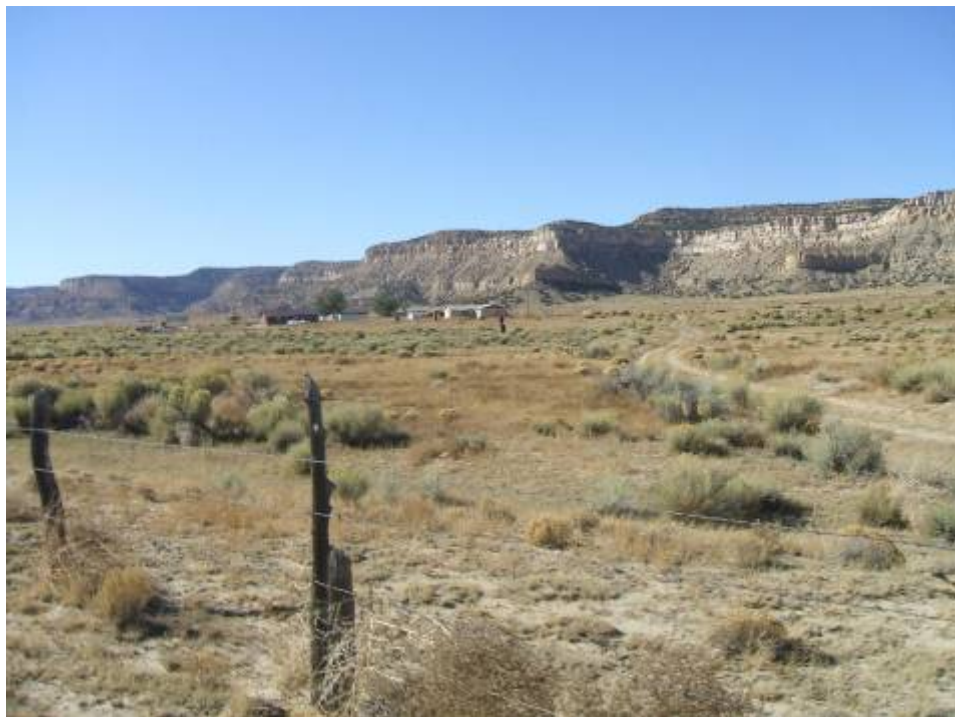
200 feet to 0.25 mile: 1 home located approximately 300 feet west of the site (Photo 8). Home also includes 3 small structures and a water tank. The source of water for the tank is unknown. Field personnel was unable to contact the occupants.

Photo 8. Housing complex located approximately 200 feet west-northwest of the mine site, towards the west

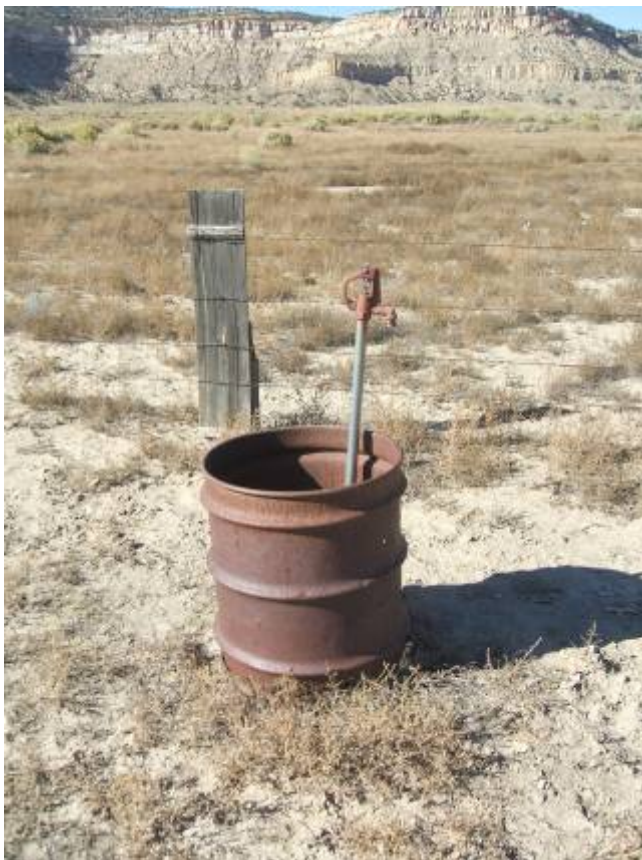
0 to 0.25 miles: Water pump observed in the western area of the site (Photo 9), likely used for livestock. A water tank associated with the home to the west of the site was observed. Field personnel were unable to determine the source or use of the tank.

Photo 9. Water pump found along the western edge of the site, towards the west

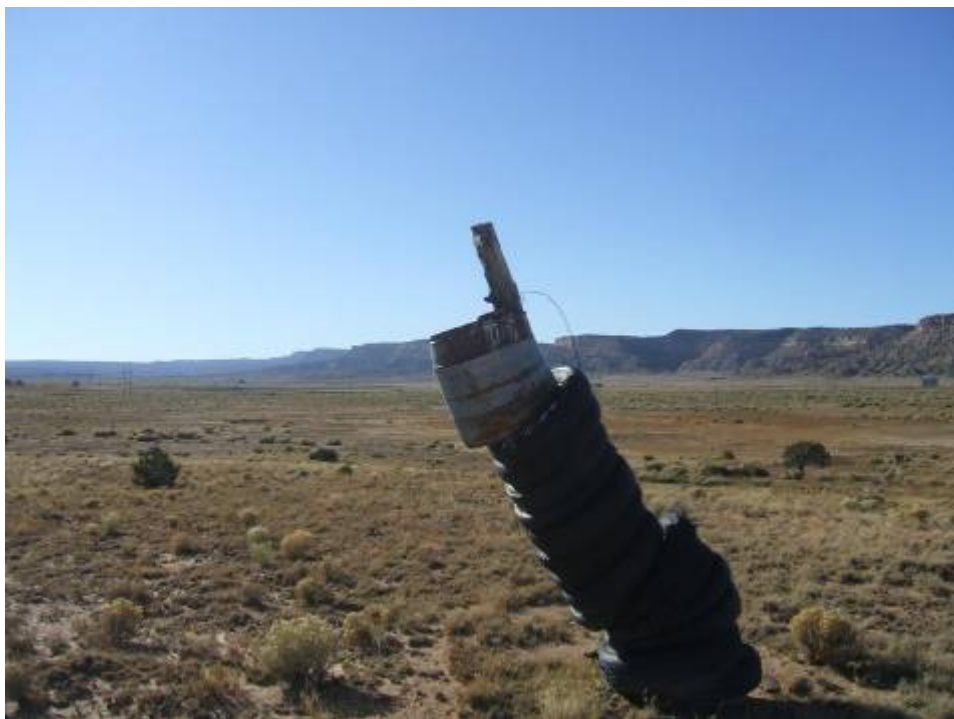
Photo 10. Wooden pole with tires and metal sheeting found in the center of the site, towards the south

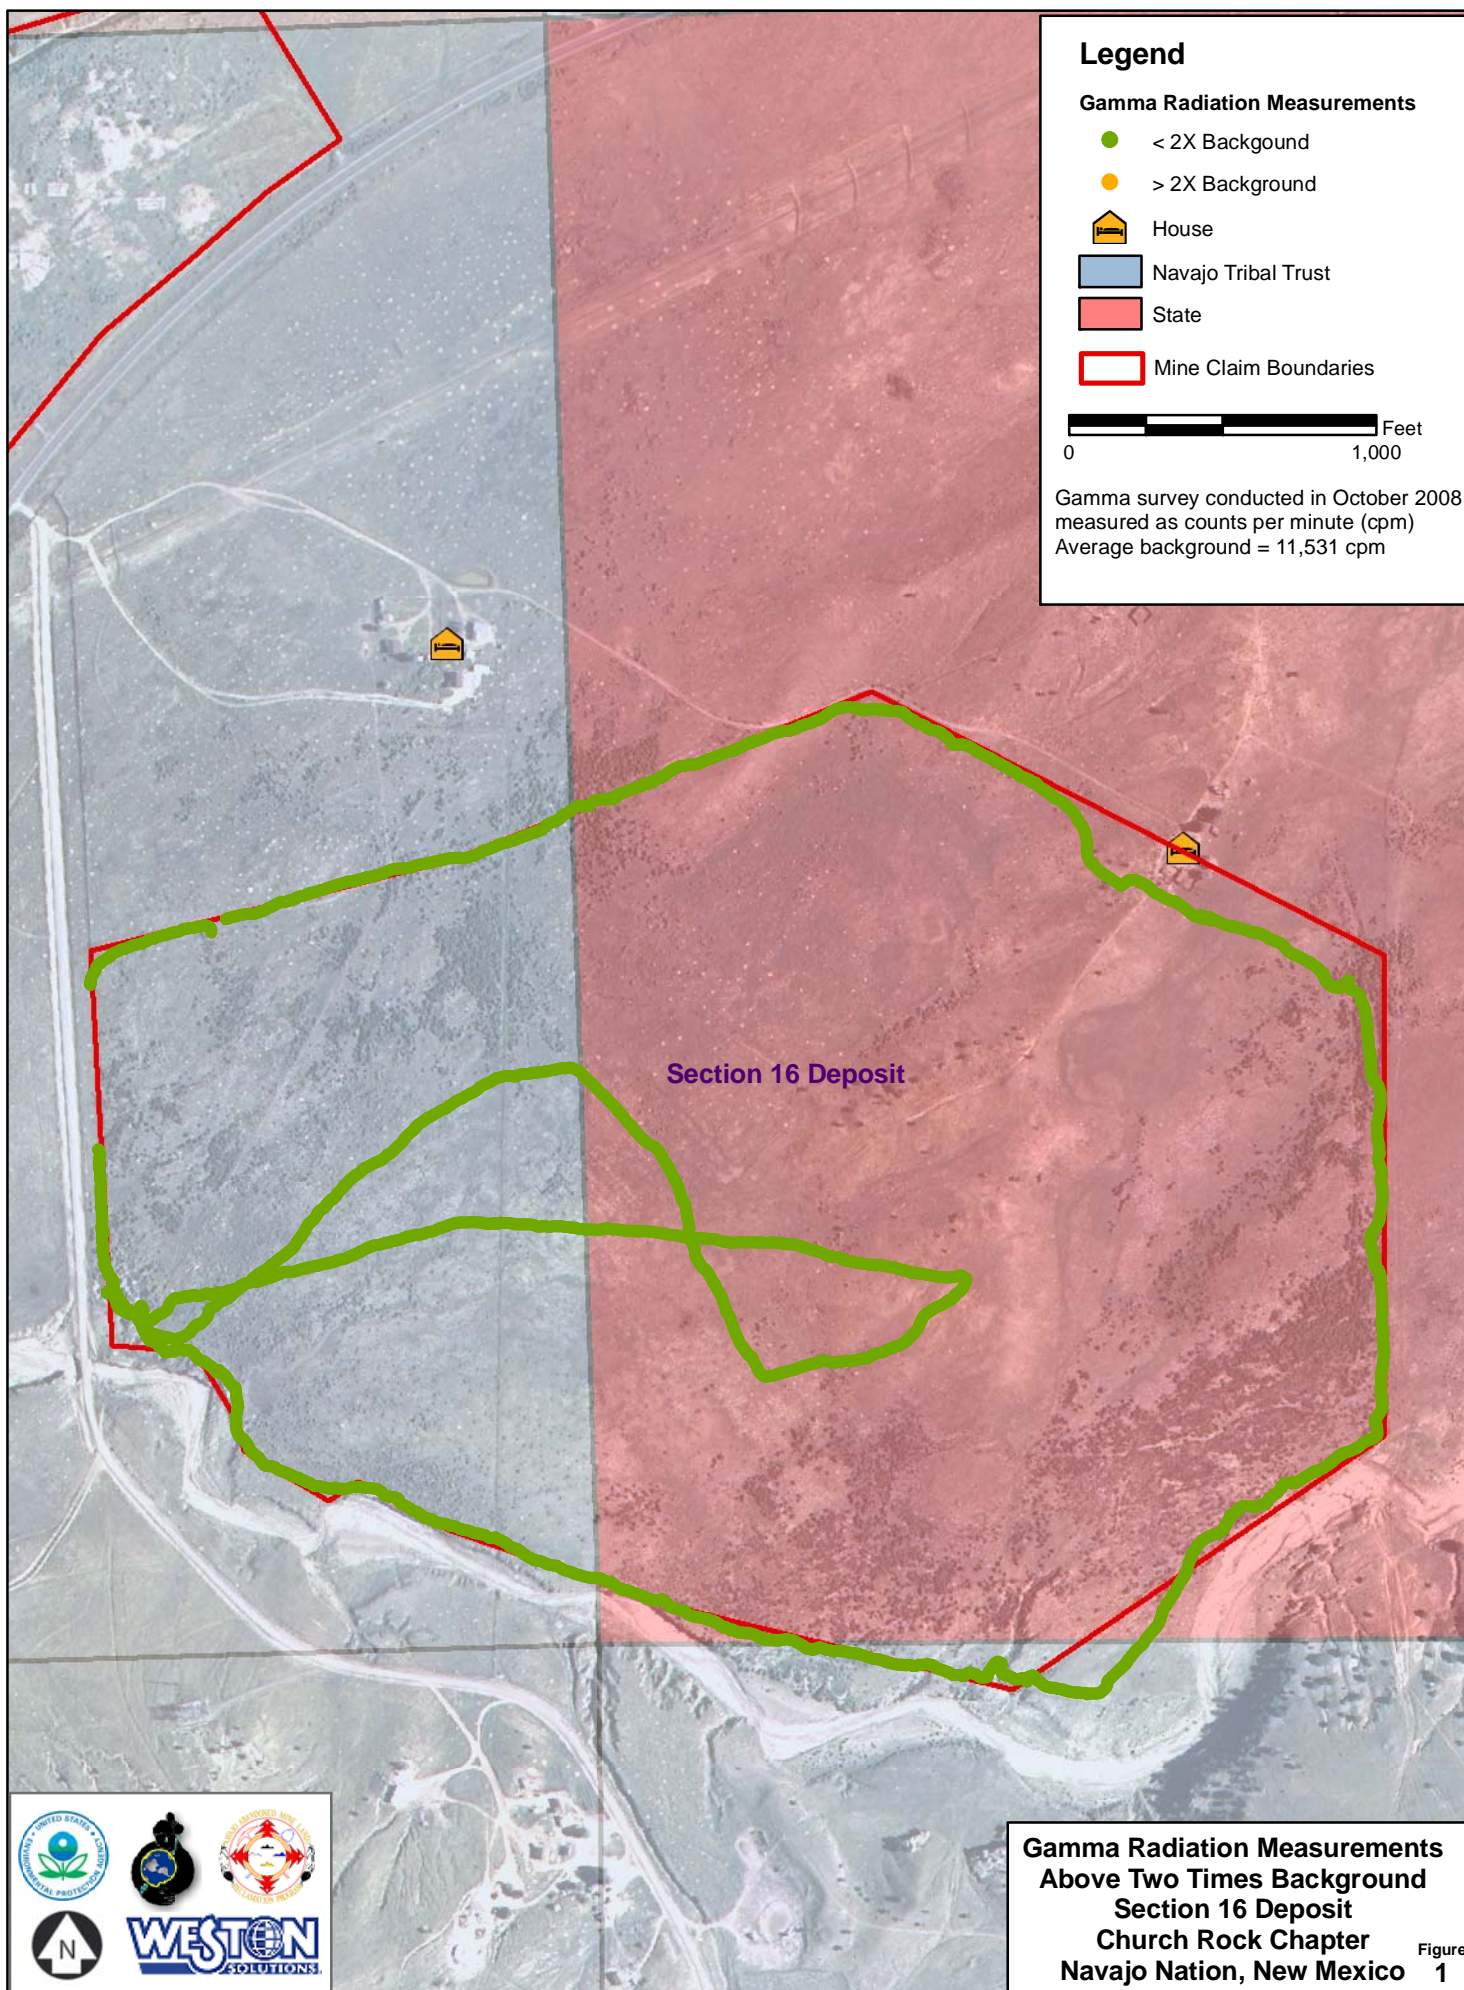
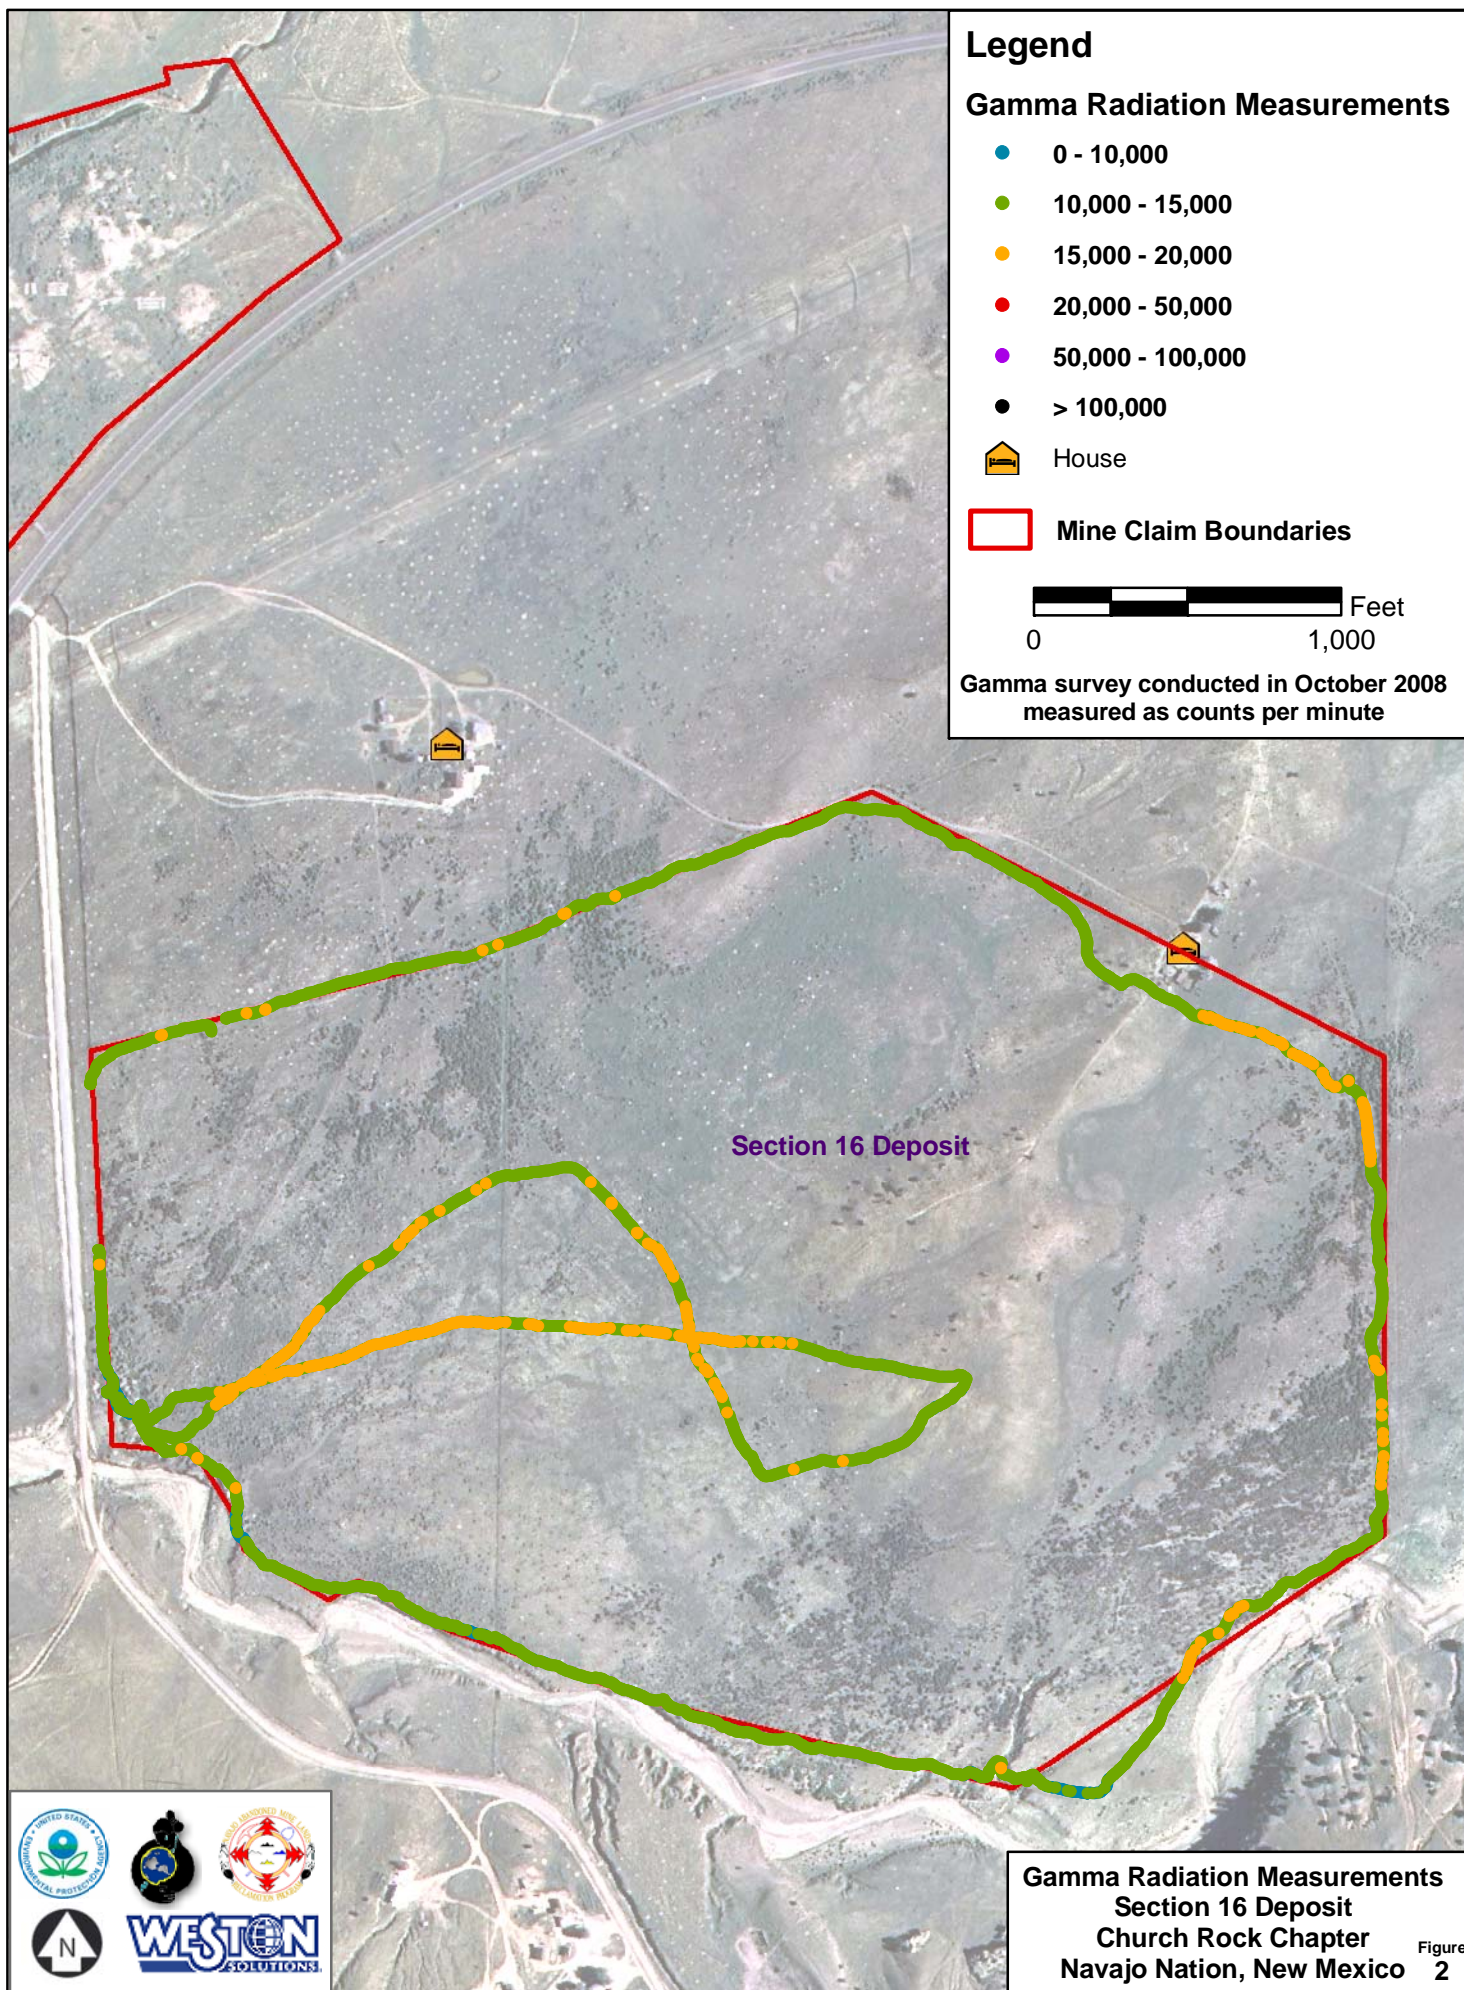
A total of 5,600 gamma radiation measurements were collected from mine sites, ranging from 7,130 cpm to 18,483 cpm. The measurements are represented in Figures 1 and 2.
